The fire disaster in the Tokyo-Nagoya Nihon-zaka tunnel July 11th 1979 Shizuoka Prefecture Masahiko Kunishima · Kenichi Horikawa (*1)

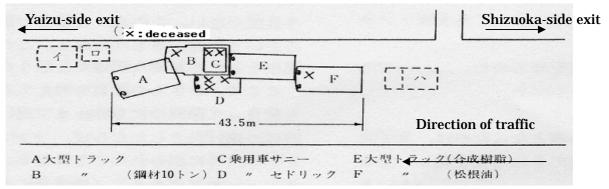
The second large truck (B) (please see Figure 1) collided with the first truck (A) from behind, and the following two passenger cars (C) and (D) collided with the truck (B) one by one. Next, the sixth vehicle, truck (F), collided with the fifth vehicle, passenger car (D), at a speed of about 100km. Because of these circumstances, the passenger cars were crushed between the trucks, then a crack was made on the gasoline tank, and the fire and explosion occurred due to an electric circuit short.

Figure 3 Sketch of the location of the disaster (Source: Fire disaster Japanese academy of fire disaster "The fire disaster of Nihon-zaka tunnel)

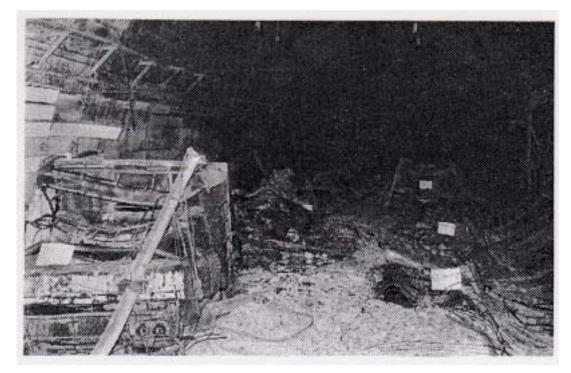
Please look at Picture 1 showing the condition of the disaster location after the fire.

Picture 1 The condition 1240m from the Shizuoka-side Exit (Source: Highway and car. The research community of highways, Nihon-zaka tunnel's fire disaster and its aid actions)

Around 19:05 A malfunction of the ITV and the lights was shown in the control room. After this time, only the ventilation fan for escaping was working. All other facilities, including lights and fire extinguishers, were not functioning because the

cables were burnt; the fuses were blown out and so on.

From July 14th, the investigation of the accident was started, and improvements of the fire extinguishing facilities and the regulations inside the tunnel were begun. These operations were completed around August 8th to September 5th. For the electric circuits of a quarter of the lights, the escape leading lights and the sprinklers, fire-proof cables were installed. This measure was not required by the regulations at that time, but was installed as a drastic measure in this case. *10 water taps for extinguishing fires were installed for every 200m of the tunnel. Before this accident, these were installed only on the entrance and exit. *Self-powered exit lights that can shine for 30 minutes after a loss of power were installed in three places, and escape leading lights were installed in eight places. *Two alert boards (one is 700m ahead of entrance, the other is at entrance) were installed. According to the regulations, one alert board 200m ahead of the entrance was enough. *The speed limit in the tunnel was fixed at 70km/h. *Lane changes in the tunnel were made illegal. *Distance confirmation sign and it on the road were made. *For the alert, thin pavement on the entrance were made.
