**Draft version to appear in “Proceedings of the ASME 2010 IDETC/CIE 2010”**

Service Information for Product Quality

Kenji Iino, SYDROSE LP, San Jose, California, USA  
Masayuki Nakao, The University of Tokyo, Tokyo, Japan

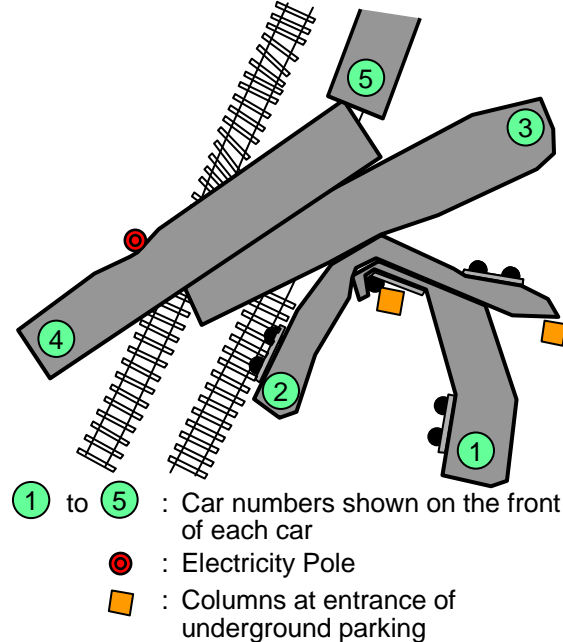
On April 25, 2005, a 7-car express passenger train of Fu-kuchiyama-line exceeded its speed limit on a curve, derailed, and crashed into an apartment building. 106 passengers were killed and 506 others were injured (Fig. 3).

**Fig. 3 Crash of the first 4 cars in Fukuchiyama accident**

While the media attacked the busy train schedule and pressure during disciplinary training after making mistakes, if an ATS was installed in the curve the accident would have been prevented. ATS stands for Automatic Train Stop (Fig. 4) that consists of a fixed device on the track and its counter part mounted on the train. When the system detects dangerous car movement including overspeed, getting too close to the preceding train, or running a red light, it forces the train to stop. Earlier systems only worked with the lights, whereas, more recent ones handle complex control algorithms.

This solution is a change in design, now implemented on the curve where the accident happened, and it has eliminated the chance of the same accident from repeating.

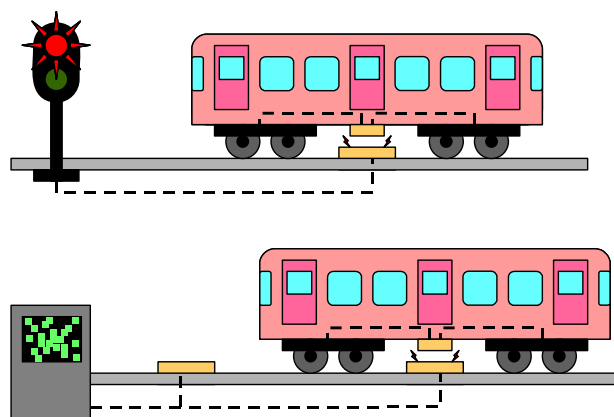
**Fig. 4 ATS systems on railway tracks**

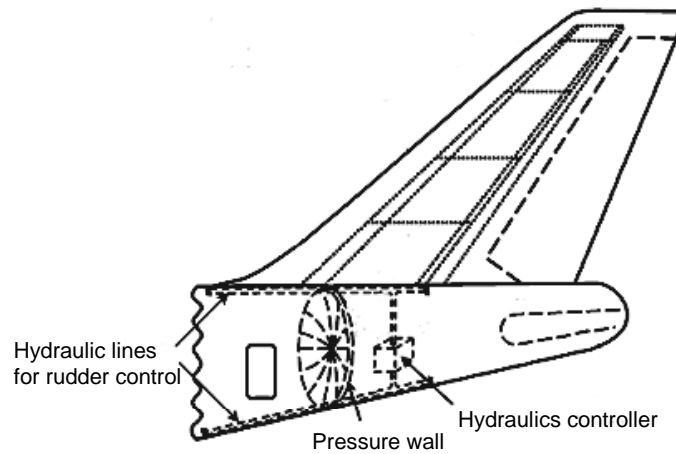
Fig. 5 Aft bulkhead of 747

Later a record of a 1978 minor accident led to the discovery of the cause. Seven years earlier, the plane had scratched its tail upon landing damaging the pressure wall. Fig. 5 shows the pressure wall installed on a 747 between the cabin and the aft pressure bulkhead. It is a hemispherical plate that keeps the cabin pressure at a level comfortable to the passengers in the high sky.

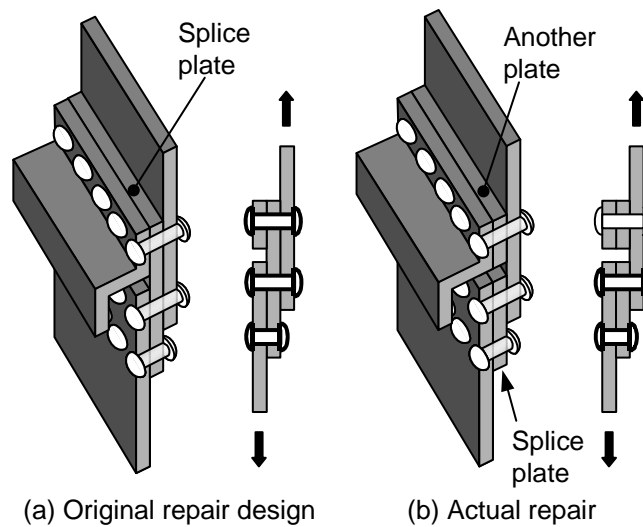
Fig. 6 Pressure wall repair on JL123

The upper and lower halves of the pressure wall are connected with rivets through a splice plate (Fig. 6). Boeing engineers repaired the pressure wall. During the repair, however, finding that the splice place they had prepared was not wide enough, the service engineers decided to split the splice plate design into two pieces installing the prepared plate on the lower half and another plate on the upper.

The three rows of rivets were designed so that each half of the pressure wall was held with two rows, and the splice plate with three. The altered repair, as seen in Fig. 6, clearly shows that the upper half of the pressure wall was connected to the splice plate/lower half assembly with a single row of rivets.

In this case, the safety engineers probably was concerned only with how the repair appeared and did not understand how they changed the structural strength of the assembly.

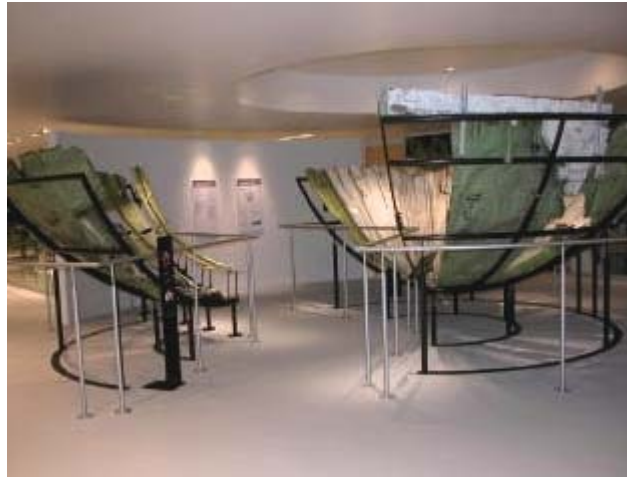
The failed pressure wall was recovered from the accident scene and is now on display at the Japan Airlines Safety Promotion Center in Tokyo (Fig. 7).

**Fig. 7 Actual pressure wall from JL123 accident**

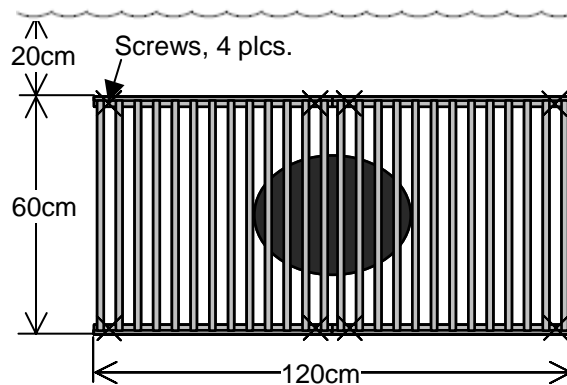
Fig. 8 shows the design. Two 60cm x 60cm stainless steel fences are fixed over the inlet hole each by 4 screws at the corners.

(a): Two 60cmx60cm fence plates cover the inlet hole

For having 4 screws on such a large piece of metal, the installers must have opened the holes by holding the fence against the 60cm x 120cm rectangular hole and using a handheld drill. There were 3 such inlet openings each with two fence plates; the total number of square fences was 6. Each fence plate can be rotated 180 degrees and the total number of possible combinations to install the 6 plates was 42. Among the 42 combinations, there was only 1 where all the screw holes and threads match perfectly as with the original configuration.

Just before opening the pool each season, it was natural that the screw holes did not match after taking the plates off to thoroughly scrub the pool and when they were replaced back on. This caused the maintenance company to fix the fences over the pump inlet holes with wire.

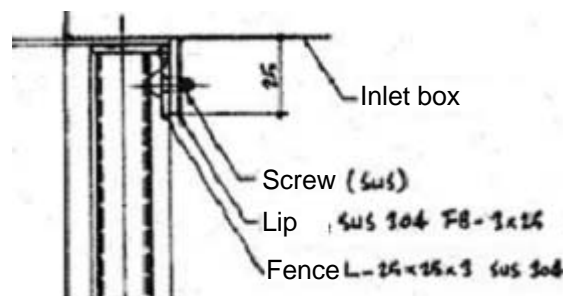
(b): Screw fixture section from actual drawing  
**Fig. 8 Pump inlet hole guard fence design**

The close-up view of a screw in Fig. 8(b) shows stainless steel lips being only 3mm thick. The screws were not called in the original drawing but they must have been either M5 or M6 each with thread pitch of 0.8mm and the later, 1.0mm, thus, there were only 3 threads on the poolside lip that engaged each screw. Water constantly flowed through the fences and naturally the fences were subject to flow induced vibration.

This design will cause the screws to loosen and drop at some point during the long summer season. Mechanical designers have a long history of battle against loosening screws from vibration. In that sense, wire, if it were thick enough to prevent kids from playing with them and taking them off, was probably more reliable than screws.

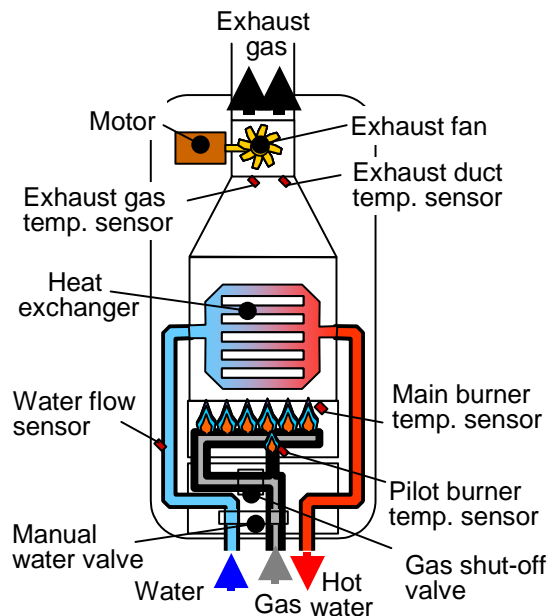
The alteration was popular among the servicemen to counter the case of gas shutting off during use. The method hot-wired the gas shut-off valve circuit that closed the solenoid valve when either i) the pilot burner was not on, ii) the main burner was too hot, or iii) the exhaust duct was overheated. Fig. 9 shows the structure of the gas operated water boiler. Besides the 3 sensors shown in Fig. 10, there were 2 others sensors for water flow and exhaust gas temperature for exhaust fan control.

**Fig. 9 Structure of the gas operated water boiler**

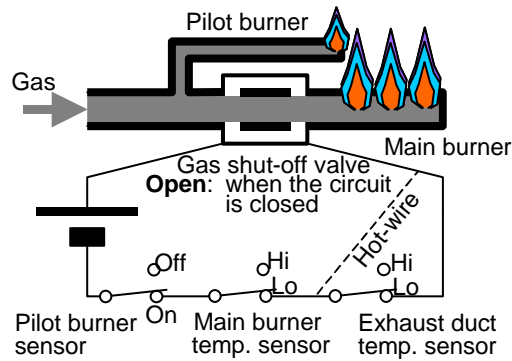
**Fig. 10 Gas shut-off valve control circuit**

Fig. 10 shows the circuit of the gas shutoff valve and how the wrong alteration was made. The electric potential to drive the circuit in the figure is shown as a battery but in fact, it was supplied from the thermocouple at the pilot burner. The first sensor to detect the pilot burner served the purpose of supplying power to the control circuit. This probably was a convenient design for boiler models designed without exhaust fans because the boiler would operate even when there was no electricity to it. The design, however, turned deadly for models with exhaust fans because the boiler would operate even when the exhaust fan was not rotating for lack of power or other reasons.

In this case, the service people only wanted to satisfy their customers without the large cost of controller replacement. They probably told the customers to keep good ventilation while using the boilers. Such information decays over time, and people do change their places of living. A new occupant of a house equipped with the wrongly altered gas boiler had no warning of keeping good ventilation while using the boiler.
