A Fatal Accident Case and Lessons for Entertainment Engineering

Kenji Iino, SYDROSE LP, San Jose, California, USA

ABSTRACT

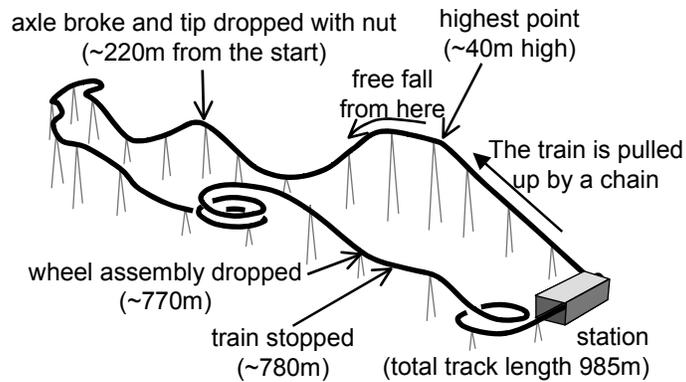
Fig. 7 Track of Fujin-Raijin II with major events during the accident

The first peak of the ride was a slow climb to the highest point. Then when the latch disengaged from the chain that was pulling the train up, it entered the free gravity fall on the track. The second high peak was immediately after the first valley, and at its top, the left side axle on the second car, Car-2, broke where indicated with a red arrow in Fig. 12 [16]. It dropped with the nut fixed on the thread with a cotter pin. While the wheel assembly lost its constraint to keep its axle pinned into the wheel platform, it survived another relatively calm 500m section but as the train exited the double-loop climb, the entire assembly fell of Car-2. Car-2's connections to Car-1 and 3 had no constraints against roll, and when the left-side wheel assembly was gone, the entire car rolled around the right side track rail for about 45 degrees.

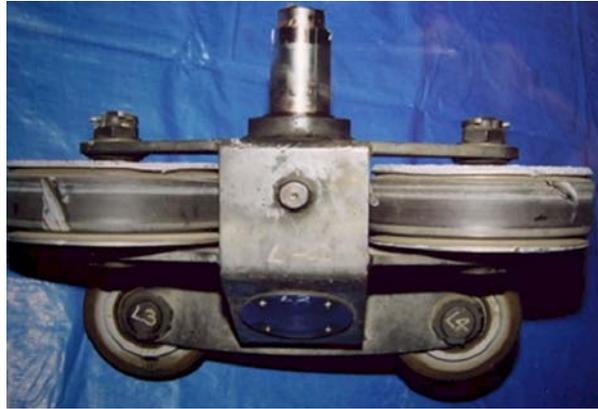
Fig. 10 Wheel assembly that fell (Top view)

The Osaka Prefecture Police (OPP) released a series of photographs of the damaged car. Fig. 10 shows the wheel assembly that fell off the car. It broke at the top of the photograph where an M32 thread extended up to engage a nut. The photograph views the assembly from above with the thread and nut missing.

After reviewing the photograph in Fig. 9, we were puzzled with the wide wear mark on the main wheels. Since the track rails are swept circles (cylinder when straight), the contact with the main wheels should be a point and thus, leave a straight-line mark on the center of wheel width (Fig. 15).

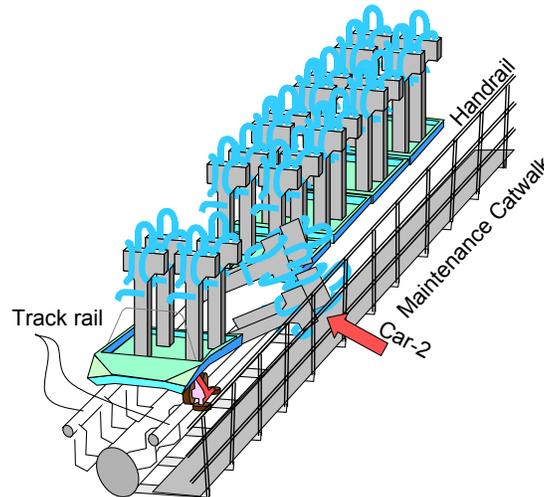
Fig. 13 Car-2 after rescue workers had arrived

her head. Fig. 13 shows how the car and the standing seats were when the emergency rescue workers were trying to remove the body. The figure is a trace of a photograph that shows all other passengers still stranded in their seats and the victim with her upper body lying on the catwalk. Bodies of the rescue workers block some of the structures in the background.

The head support seen bent backwards behind the handrail in Fig.12 was for the second passenger. That for the front row passenger that died is not seen in the picture. It was most likely removed by the rescue workers. The stand-up seat itself was pushed backwards. No question it was an immediate death.

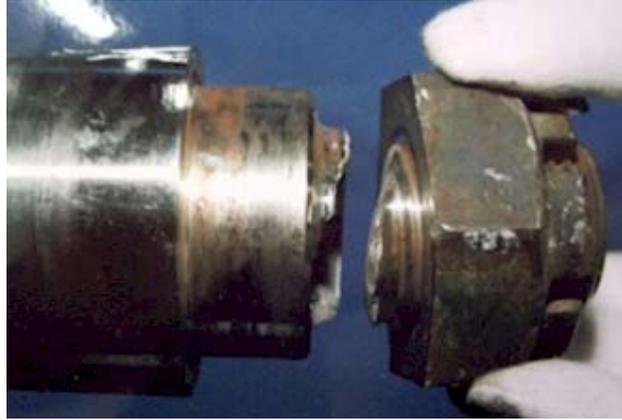
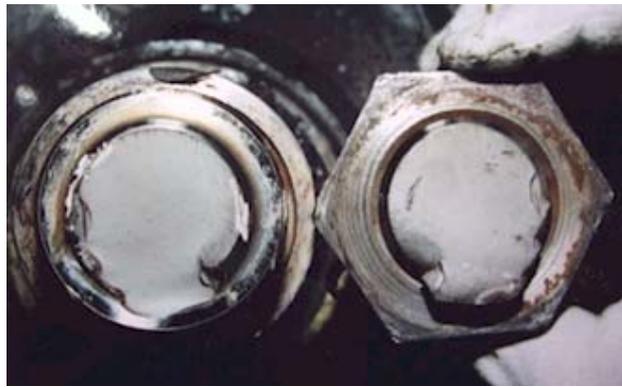
Fig. 13 Photos of the broken axle
(orientation is the same as when installed)

OPP immediately started a criminal investigation for misconduct, and then on June 4th, a month from the accident, it released a series of photographs of the failed wheel assembly including Fig. 9. Figure 13 shows the axle where it broke. Although it is hard to tell from the second photograph, specialists say the cross section showed beach marks over the upper 2/3 area of the cross section. This means at the time of failure, the axle had only 1/3 of the original cross section intact to hold onto the wheel assembly. What we can see from Fig. 13 is that the crack initiated at the bottom of the minor diameter at the upper side of the axle. As figures 8 and 11 show, the wheel assembly does not turn at high speed like wheels. It may rotate for a few degrees to keep itself on the track, nonetheless, the axle is subject to repeated stress cycles as the cars travel on the twisted track.

It was later disclosed that Expoland, the owner of the park, never exchanged the axles on the cars throughout the 15 years of operating Fuji-Raijin II. Their annual inspections took the wheel assembly apart, however, only made visual observations of the parts. The park continued to report “nothing to report, in good condition” to the administration. Poor maintenance, or perhaps a better word is, negligence was a large cause of this accident.

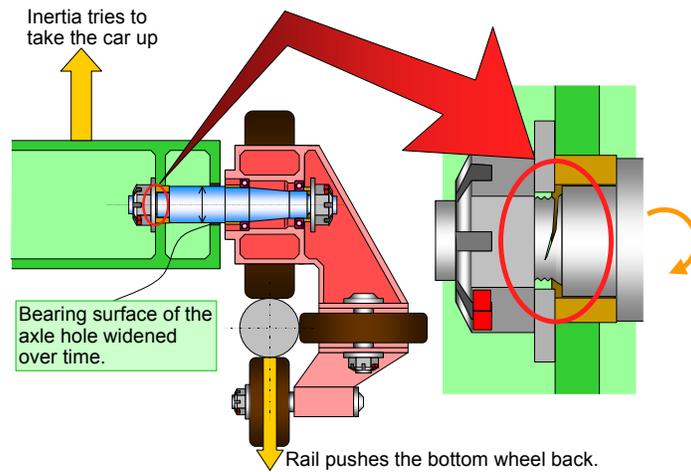
Fig. 14 Mechanism of axle failure

Note from Fig. 7 that the axle broke when the train reached the top of the first hill after the initial drop. Fig. 14 shows our conjecture of how the axle eventually broke at this location. The upward inertia put bending force on the axle.

Due to gravity on the car and wheel assembly, the bending force is greater at track valleys rather than hills, however, as the crack was initiated at the high end of the axle neck, bending force when the rising car was forced to turn down worked to spread the crack.

The initial design intended the mating hole in the wheel platform (bearing surface on axle hole in Fig. 14) to carry most of the bending force. Iino estimated the bending stress in the axis in this case not to exceed 6kgf/mm^2 [16]. We can easily guess that the axle would hardly rotate because the wheel assembly is attached to it via two ball bearings. Over time, however, with pulling it out for inspection and pushing it back in, the surface will wear. A maintenance worker later confessed that within 5 to 6 years, the axles’ fits were loose and they used glue to keep them tight [18].

Iino estimated the maximum bending stress to exceed 100kgf/mm^2 at the neck [16] when the train was subject to 3G at the bottom of the first valley, assuming there was no support at the axle hole. He also estimated the bending stress, when the car was banked by 45 degrees, to be at the same level. Iino’s analysis, however, had to assume quantities like the car’s dead weight, velocity, and track’s bank angle from photographs. Again, it was unfortunate that no formal report was published other than police’s press releases about the physics of the accident.

The axle was made of nickel-chrome alloy with tensile strength of 75kgf/mm^2 . When material is subject to repeated stress cycles, the design textbooks recommend keeping the stress below 25 to 48kgf/mm^2 by multiplying a factor of 0.35 to 0.64, e.g., [19]. The factor of safety in this case is the reciprocal of the multiplying numbers, thus 1.6 to 2.8. Although conservative and rough, the bending stress in excess of 100kgf/mm^2 clearly violates this requirement.

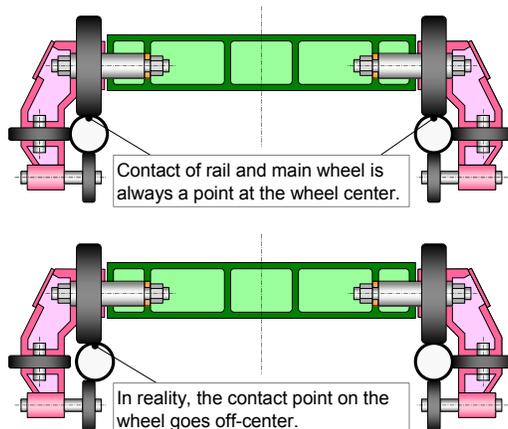
Fig. 15 Gap between side wheels and rail

We then realized for the rigid wheel assembly in Fig. 8, it is practically impossible to keep tight contact of the side wheels for the entire length of the 985-meter ride. Instead of keeping contact all the time, the side wheels on the left and right side assemblies would alternate which side was in contact depending on where the car was on the track. The broken axle thread was M32, so from Fig. 9, the wear mark was about 50mm, thus the biggest gap between the track rail and side wheels was about 50mm.

In May 1990, the predecessor Fuji-Raijin had an incident of getting stuck on the track in the middle of a ride. This was probably due to the warm weather expanding the width of the two track rails wider than what the narrowest wheel assembly pair could handle. Mechanical engineers are good at managing microscopic tolerance of machines, however, when it comes to large structures, we tend to forget that they also have building tolerances as well, and they are much larger than what we

are used to. Although we cannot estimate the resulting impact forces upon the cars swaying sideways and hitting the rail, they must have been quite significant.
