Fukushima Accident Summary(1)

2011-June-26, Ritsuo Yoshioka
(Blue-colored note is Yoshioka's comment)

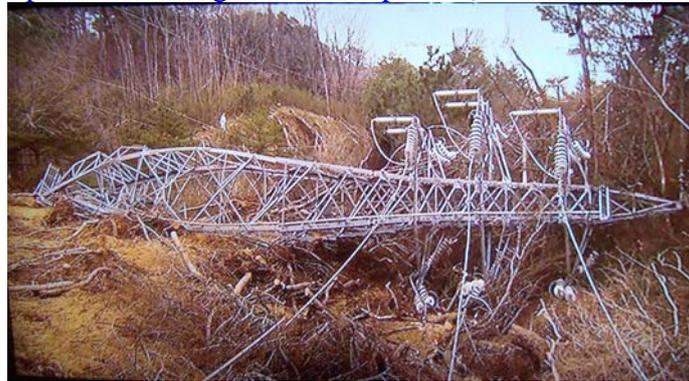
All the reactors of F1 (Fukushima-unit 1), F2, and F3 scrambled to fully insert all the control rods. Meanwhile, F4/5/6 were in their periodic inspection stages. The facilities to receive the external electric power for F1/2/3/4 were all destroyed by the earthquake because they were designed to withstand the lowest seismic level (current Japanese licensing criteria).

The earthquake also took down the steel tower for external power supply to F5/6. (If this power line was alive, F1/2/3/4 reactors could have survived several days after the earthquake, and we might have found a solution to provide cooling within this period.)

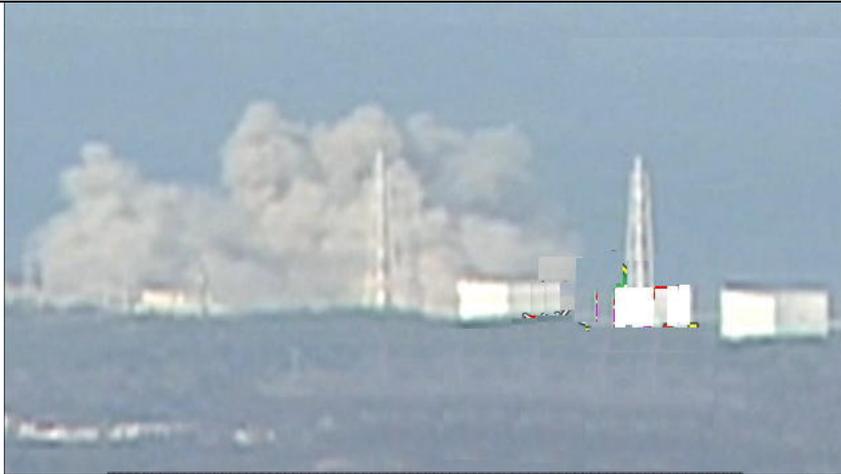
Hydrogen explosion of F1

15:36	<p>There was an explosion at the top of reactor building of Unit 1.</p> <p>Concrete panels on the sidewalls of the top floor and top-roof are intentionally made thin. They are designed to rupture in case of pressure buildup in the building after an accident. The rupture keeps integrity of the whole building. (I tried to find veteran GE designers to hear why they applied this design, but no luck here so far. If these walls were thick, an explosion with a larger energy could destroy the PCV.)</p>
-------	---
