## Fukushima Accident Summary(3)

2011-July-17, Ritsuo Yoshioka

### 2) Fukushima-3 Reactor

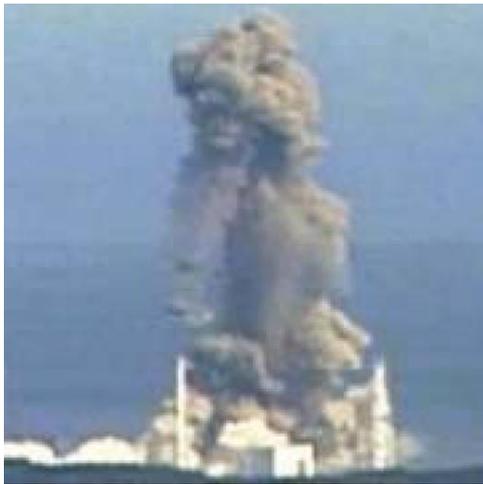
| 11:01 | There was an explosion at the top of the reactor building of Unit 3.<br>Concrete/steel panels on the sidewall/roof of the top floor are designed to rupture, in case of over-pressure such as steam line breakage within the reactor building.<br>(So, they ruptured as designed, although hydrogen explosion might not have been predicted before.) |

Hydrogen explosion at F3

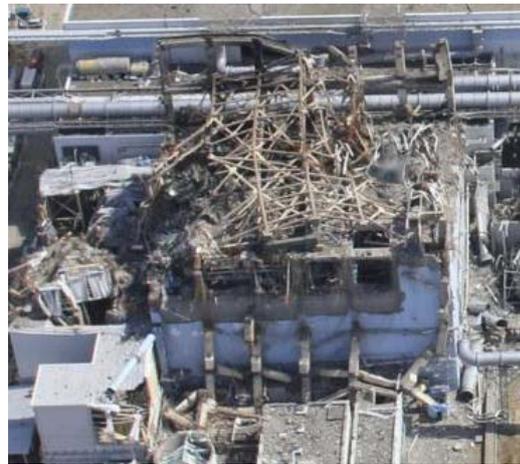
Top (5th) floor and walls at 4th floor were destroyed.

Smoke reached 300-meters high, and the explosion was bigger than that at F1. Actually, F3 steel frameworks were destroyed, and this did not happen with F1.

(This cause might have been more hydrogen generation than F1, due to the larger fuel inventory at F3. When this explosion occurred, I was in a TV studio, and was surprised by this news.)

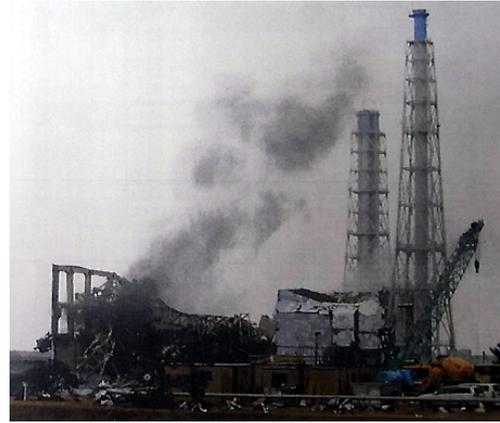
Black smoke suggests carbon from organic material such as cable insulators. There are many cables under the bottom of RPV for the control rod drive mechanism and neutron detectors, as shown in the lower-left photo. As Report-1 explained, hot fuel broke the instrument tubes, and fell down to the bottom of RPV, and likely burned the cables.

The French national laboratory IRSN suggested that “core-concrete chemical reaction” was responsible for the black smoke. Of course, hot fuel fell down on the concrete floor of the PCV, as shown in the lower-right figure, however, a Japanese national laboratory says that Japanese plants do not use concrete with carbon, and this reaction will not occur.

My intuition says that this black smoke was caused by fire of the cables when hot fuel fell on them.

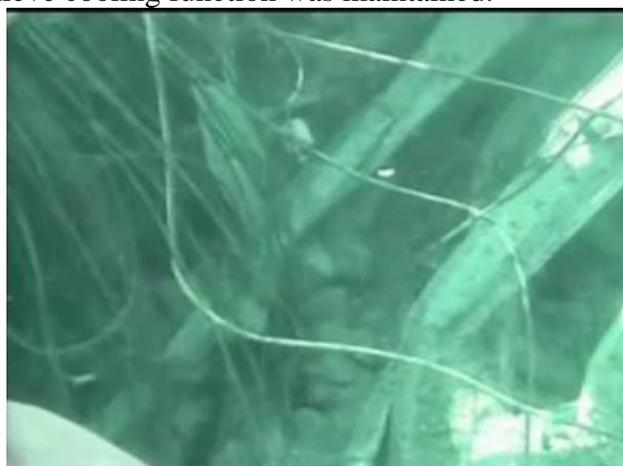
The hydrogen explosion on March 14th dropped concrete panels and iron framework in the spent fuel pool, and we cannot see if the fuel bundles are intact or not. Cooling function for the spent fuel was lost on March 11th, but sea water was injected after March 13th. Decay heat in F3 spent fuel pool is not large and I believe cooling function was maintained.
