A Fatal Accident Case and Lessons for Entertainment Engineering

Kenji Iino, SYDROSE LP, San Jose, California, USA

ABSTRACT

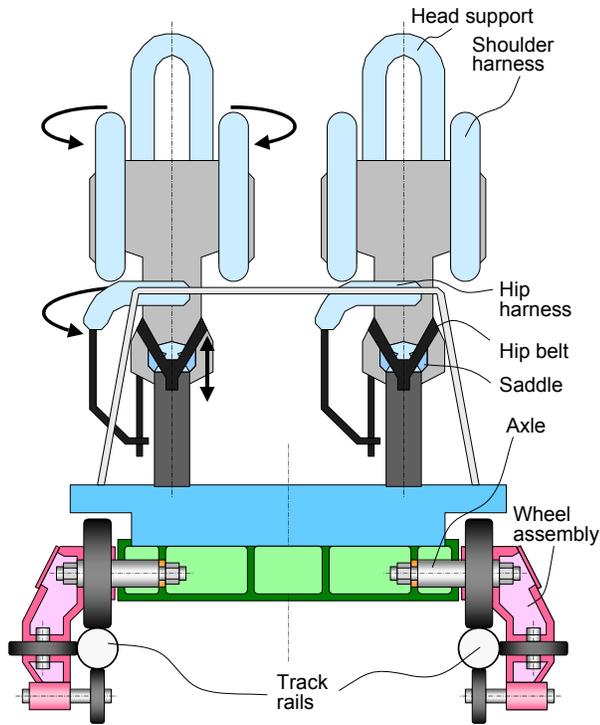
Fig. 8 Front view of a Fujin car

Unfortunately, there were no thorough investigation report by the Ministry of Land, Infrastructure, Transport and Tourism (MLIT) of the Japanese government other than press releases and statistical reports on investigations of other amusement rides in the country, e.g., [13]. With the attraction closed, we can only judge from pictures about the cars as we explain here. Each train had six cars. Each of the first five had two wheel assemblies in the left and right front and was connected to the trailing car. The connection was attached to the trailing car in a way it was free to rotate in all directions so the train could follow the twisting and swirling track. The last car had another pair of wheel assemblies in the back. Fig. 8 shows the front view of a car of Fujin.

We then realized for the rigid wheel assembly in Fig. 8, it is practically impossible to keep tight contact of the side wheels for the entire length of the 985-meter ride. Instead of keeping contact all the time, the side wheels on the left and right side assemblies would alternate which side was in contact depending on where the car was on the track. The broken axle thread was M32, so from Fig. 9, the wear mark was about 50mm, thus the biggest gap between the track rail and side wheels was about 50mm.

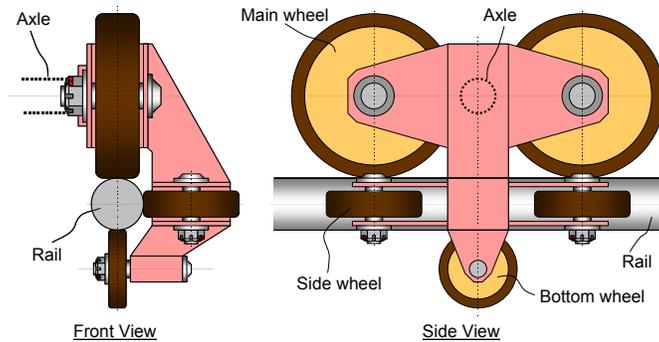
Fig. 11 Wheel assembly

The assembly had two main wheels on the top, two side wheels to prevent yaw [14], and a bottom wheel to keep the car on track without letting it jump up off the rail. Fig. 11 shows the assembly, in which the failed axle is drawn with dotted lines. The five wheels rotate individually around their own axles, and in addition, the entire assembly rotates about the axle shown in dotted lines.

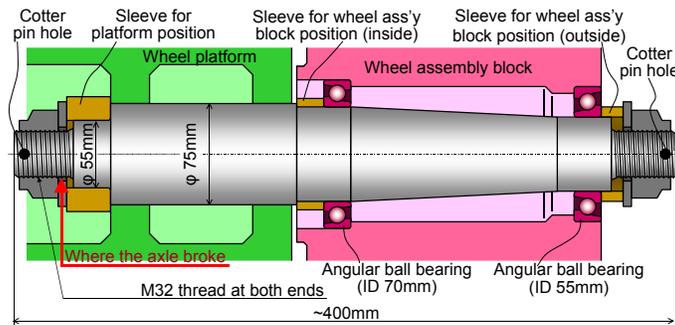
Fig. 12 Wheel assembly axle

Even though we could not get our hands on a complete drawing of the machine, subassemblies, or its parts, there was some information available on the Internet. With the penname SUBAL, an unidentified person runs a BLOG [15] which has a series of articles of his conjecture about the cause of the accident. The articles give valuable information and suggestions about analysis into the cause. He claims that he obtained a copy of the drawings of the wheel assembly without identifying the source, however, we will rely on this information for further discussions. The dimensions available from SUBAL's BLOG prove fairly adequate when compared with photographs from other sources. Fig. 11 shows the axle which we concluded its configuration in this manner.
